INSPEC-PRO

PROFESSIONAL HOME INSPECTION.

RE: Report No. 1024
1583 Montée Paiment
Val des monts, QC
J8N 7P5

Report No. 1024
For inspection at:
1583 Montée Paiment
Val des monts, QC
J8N 7P5
on: Tuesday, June 27, 2017

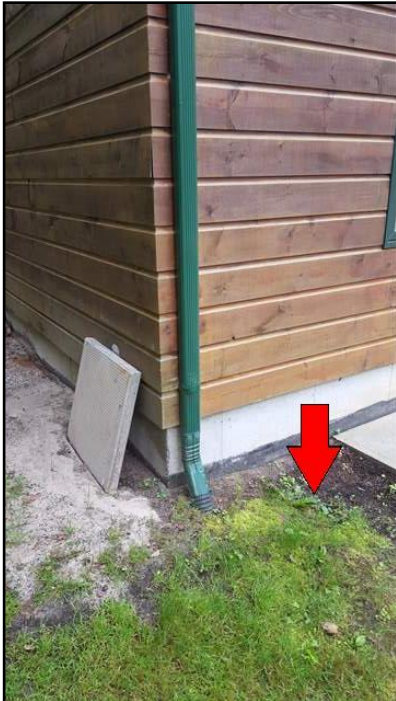
2. Condition: • [Downspouts discharging below grade](#)

Implication(s): Chance of water damage to contents, finishes and/or structure

1. Downspouts discharging below grade

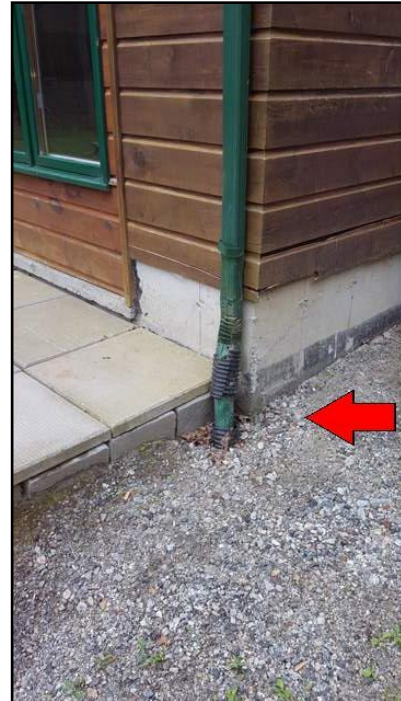
2. Downspouts discharging below grade

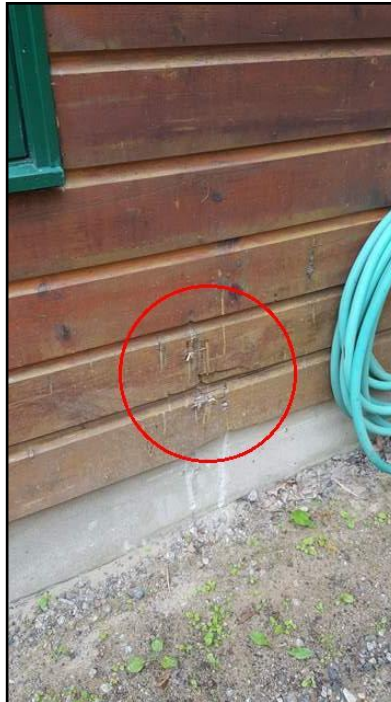
3. Condition: • [Cracked, split or broken](#)

Implication(s): Chance of water damage to contents, finishes and/or structure

3. Cracked, split or broken

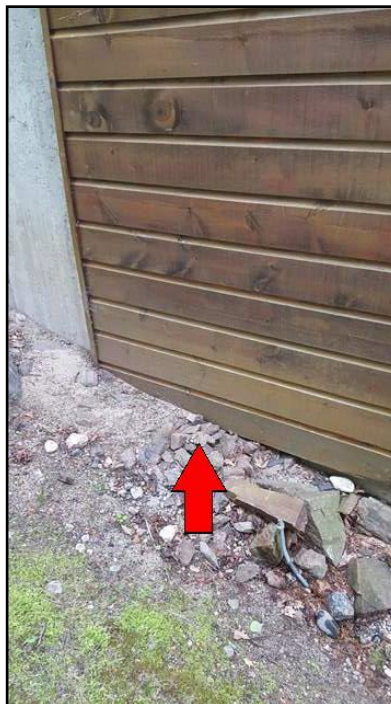
4. Condition: • [Too close to grade](#)

Implication(s): Chance of water damage to contents, finishes and/or structure | Material deterioration | Rot | Insect damage

4. Too close to grade

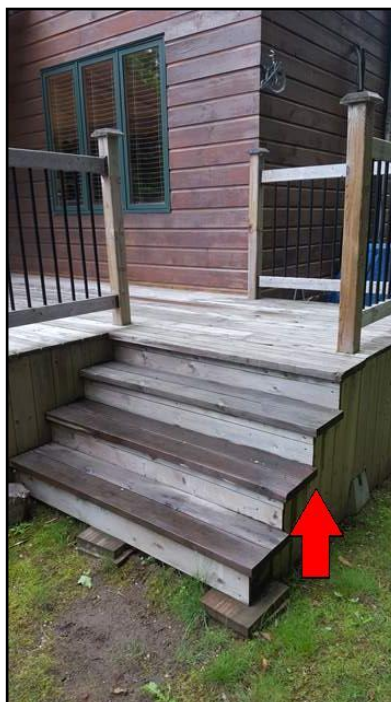
5. Condition: • [Missing](#)

Implication(s): Fall hazard

5. Missing

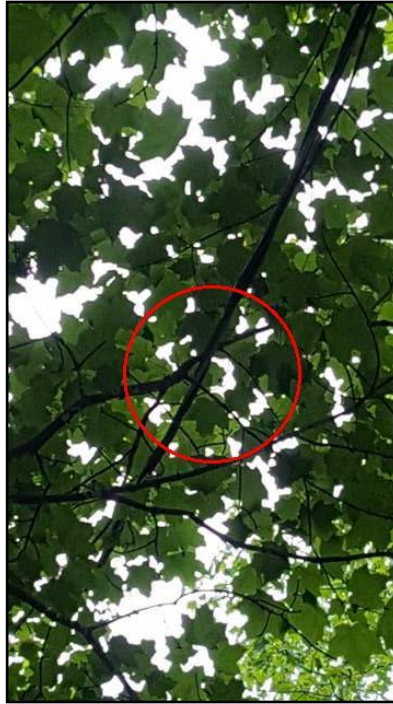
7. Condition: • [Branches, vines interfering with wires](#)

6. Branches, vines interfering with wires

I recommend that the trees get cut back where the service wires is running from the pole to the house. This is normally done by the service provider.

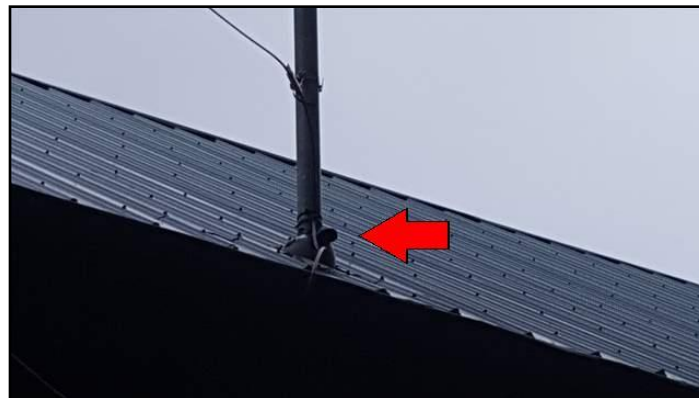
8. Condition: • [Mast not weather-tight](#)

There is possible water entry location at the electric mast flashing.

7. Must not weather-tight

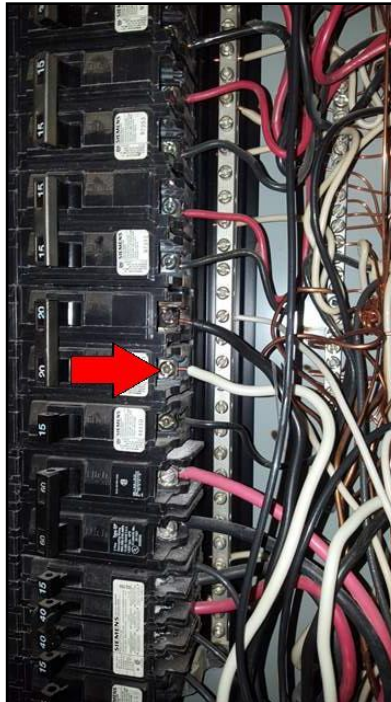
9. Condition: • [Fused neutral](#)

White wires is neutral wire, once the neutral wire is used as a hot wire the white wire needs to be color coded so service people will know that this wire is live.

8. Fused neutral

This can be done by marking the wire with a black marker or by wrapping black electrical tape around the wire. This must only be done by a qualified electrician.

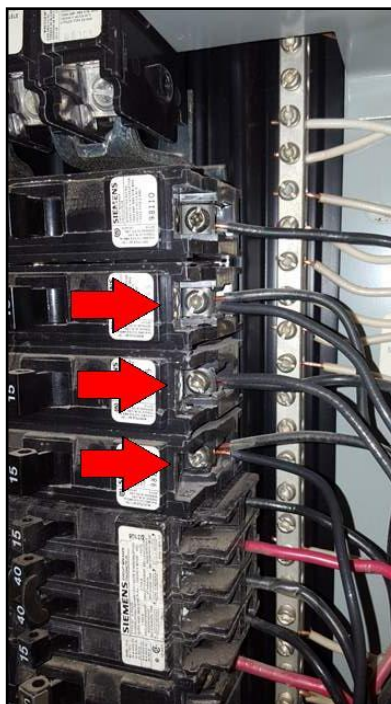
10. Condition: • [Double taps](#)

There is double taps in the electrical panel this is when two wires is attached to one breaker this is not recommended.

9. Double taps

I recommend that a qualified electrician come out and rectify these problems.

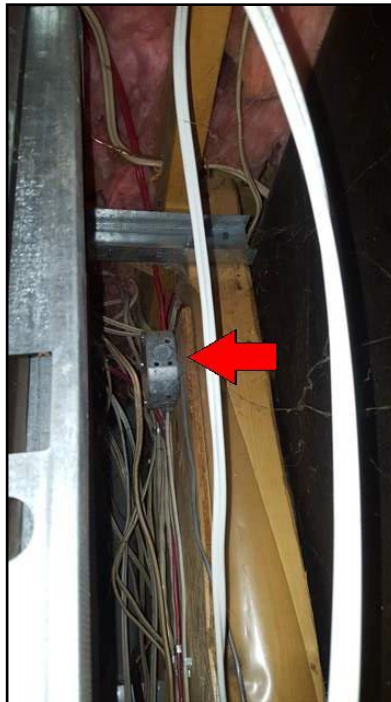
11. Condition: • [Concealed boxes](#)

I found one junction box that was located behind the drywall all junction boxes should be accessible in case of emergency.

10. Concealed boxes

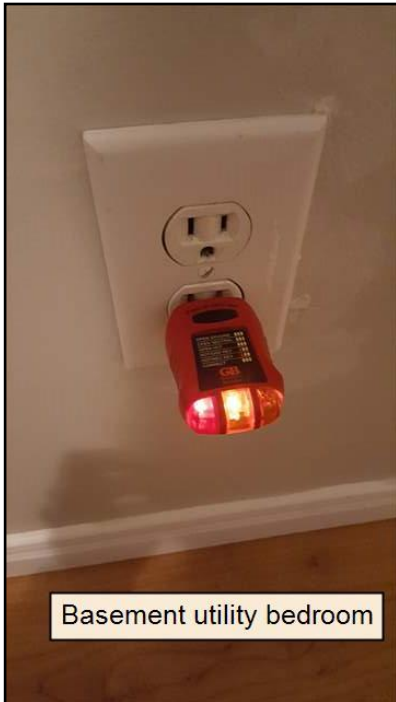
Basement utility bedroom

12. Condition: • [Reversed polarity](#)

11. *Reversed polarity*

Reverse polarity is when the hot and neutral connection at the receptacle are wired backwards. During the inspection I found a couple of outlets with reverse polarity I recommend that a qualified electrician come out and correct these problems and have a look at all the receptacles at the property to make sure that they are wired correctly.

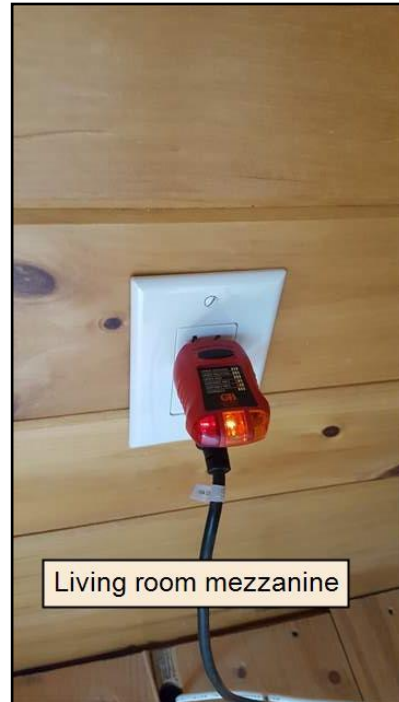
Living room mezzanine

12. *Reversed polarity*

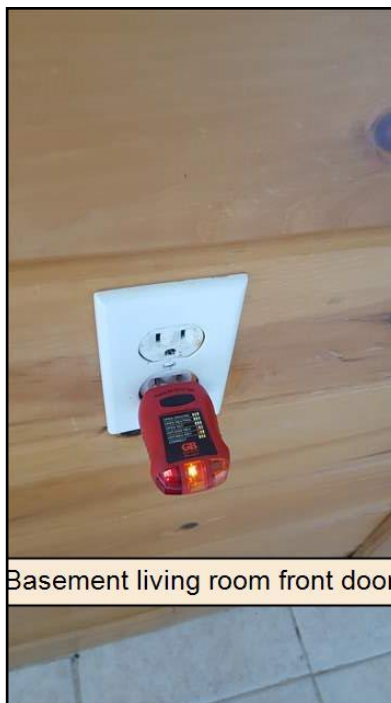
Basement living room front door

13. *Reversed polarity*

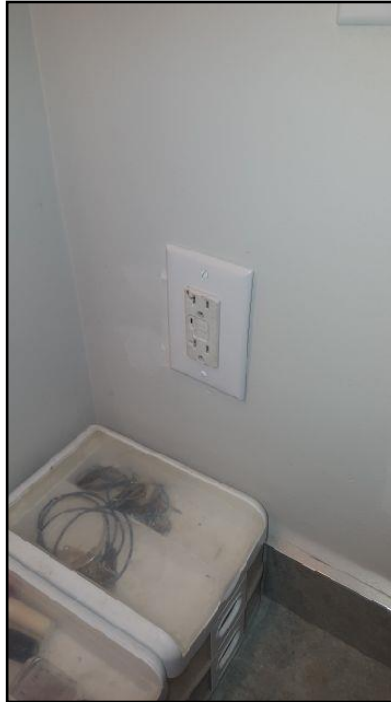
13. Condition: • [Test faulty on GFCI/GFI \(Ground Fault Circuit Interrupter\)](#)

14. Test faulty on GFCI/GFI (Ground Fault...

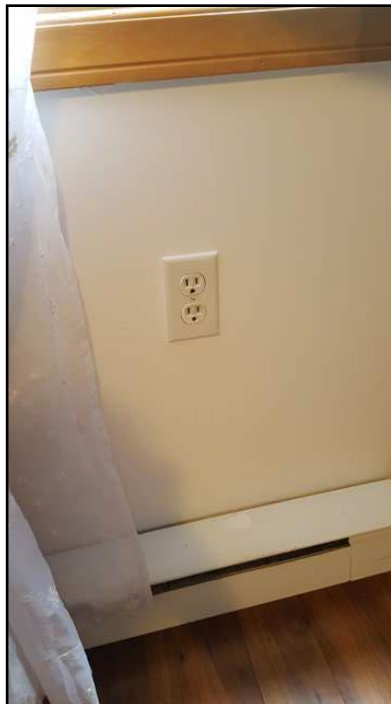
14. Condition: • [Above electric baseboard heaters](#)

Implication(s): Increased fire hazard

15. Above electric baseboard heaters

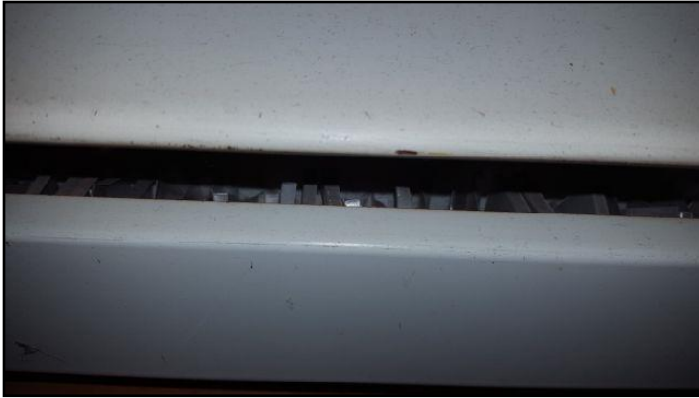
18. Condition: • [Dirty or bent fins on heaters](#)

16. *Bent fins on heaters*

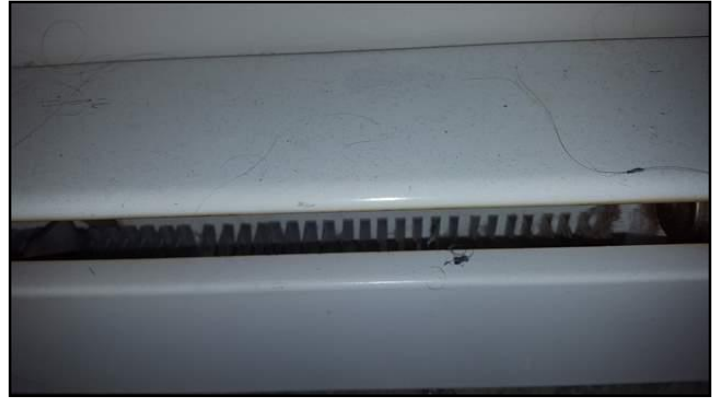
17. *Bent fins on heaters*

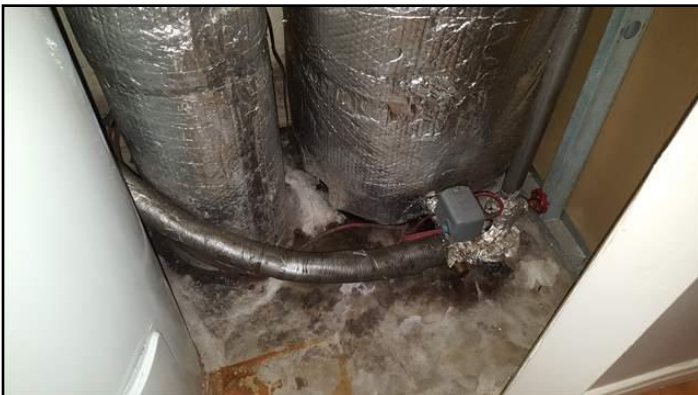
18.

21. Condition: • I recommend that the pressure tank and any related equipment be lifted from the concrete floor. This will allow air movement and protect the metal from rusting.

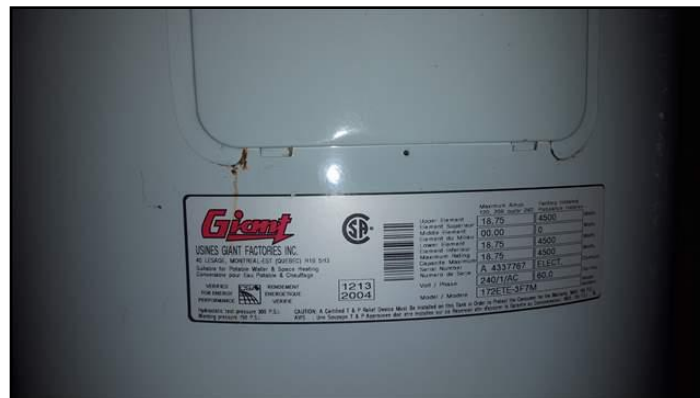
22. Condition: • Past life expectancy

20. Past life expectancy

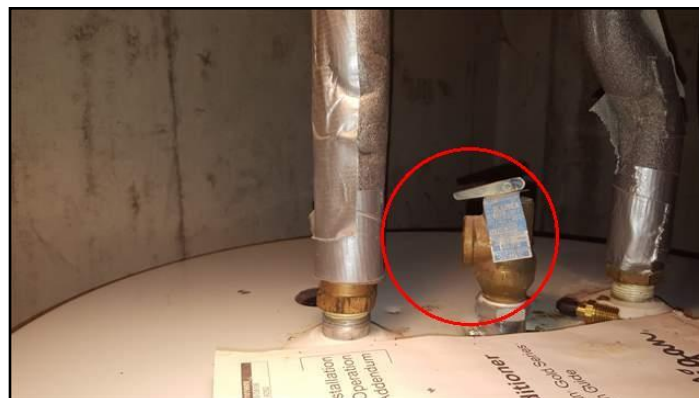
23. Condition: • [Discharge tube missing](#)

21. Discharge tube missing

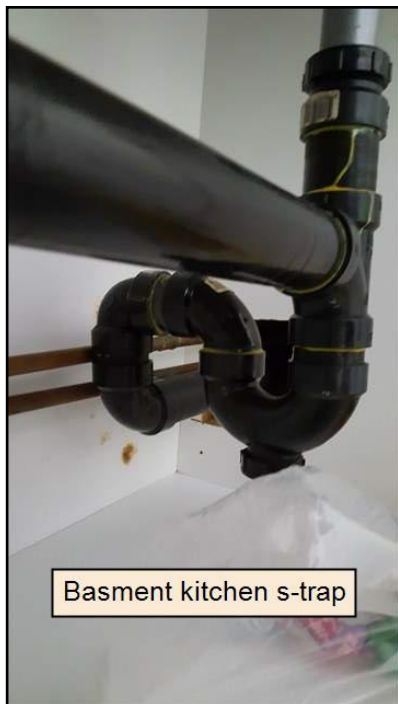
24. Condition: • [Nonstandard shape or material](#)

22. Nonstandard shape or material

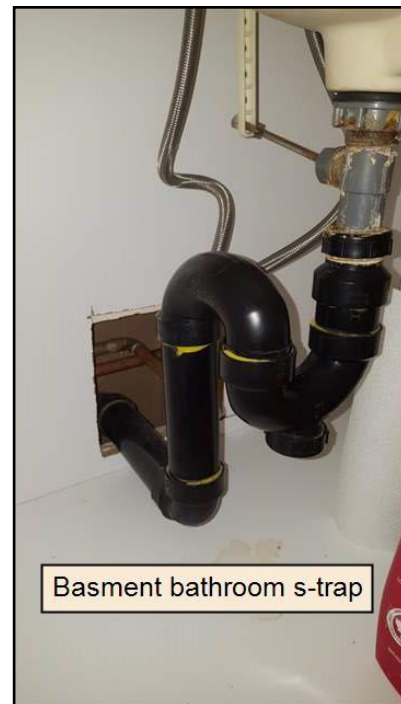
23. Nonstandard shape or material

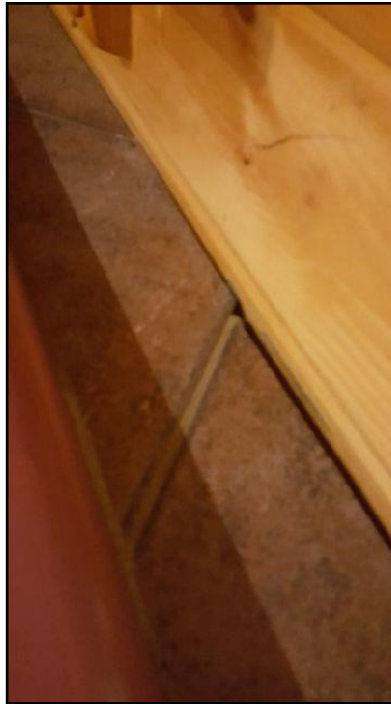
25. Condition: • [Caulking loose, missing or deteriorated](#)

Implication(s): Chance of water damage to contents, finishes and/or structure

24. Caulking loose, missing or deteriorated

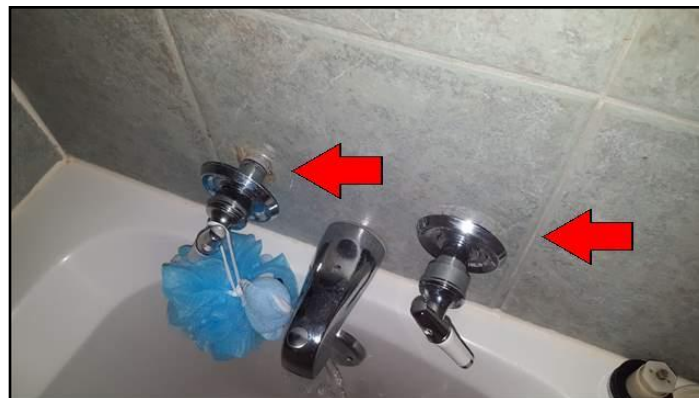
26. Condition: • [Caulking loose, missing or deteriorated](#)

Implication(s): Chance of water damage to contents, finishes and/or structure

25. Caulking loose, missing or deteriorated

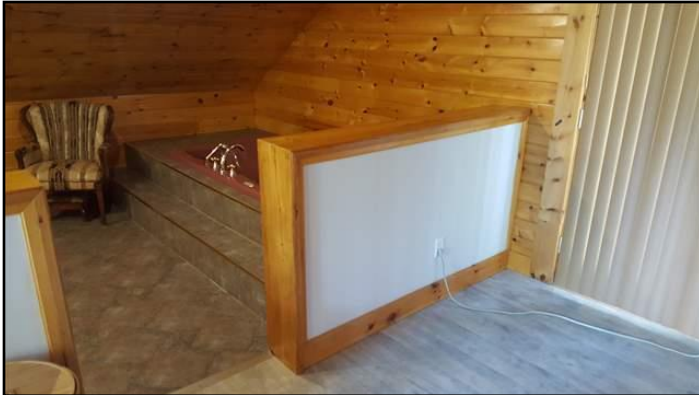
27. Condition: • [No pump access](#)

26. No pump access

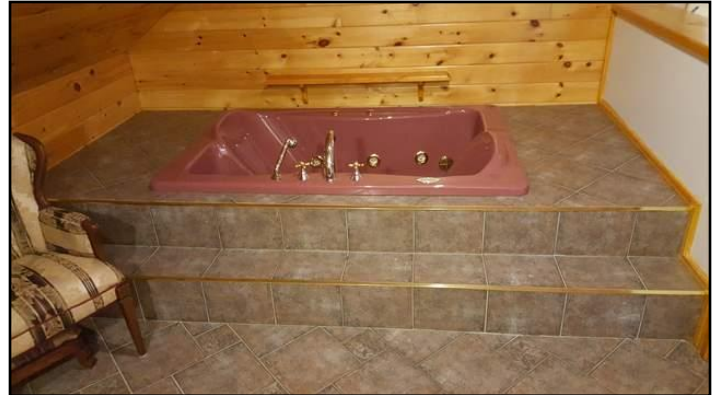
27. No pump access

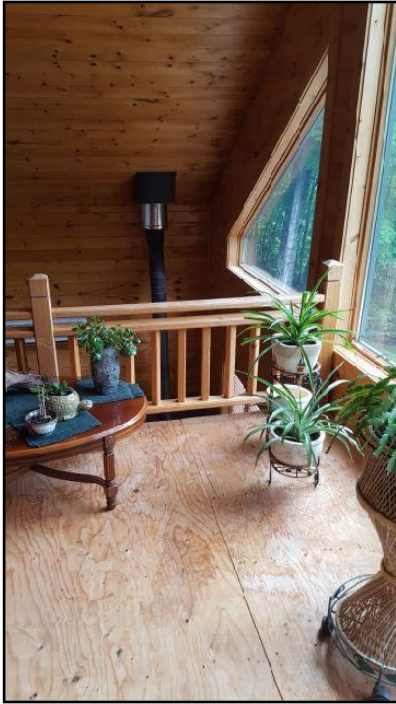
The handrails leading up to the mezzanine and the guard rails at the top of the mezzanine we're very low. This is a life safety issue and needs to be corrected immediately.

28. Condition: • [Too low](#)

28. Too low

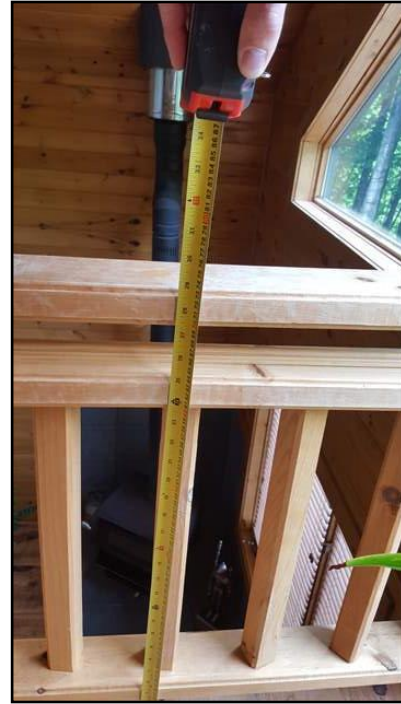
29. Too low

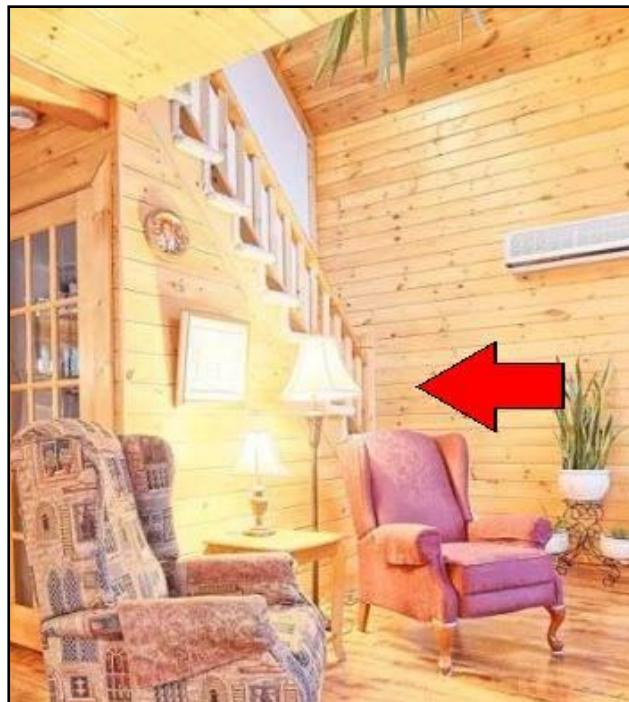
29. Condition: • [Loose](#)

The guardrail and handrail were loose and needs to be re-secured.

30. Loose

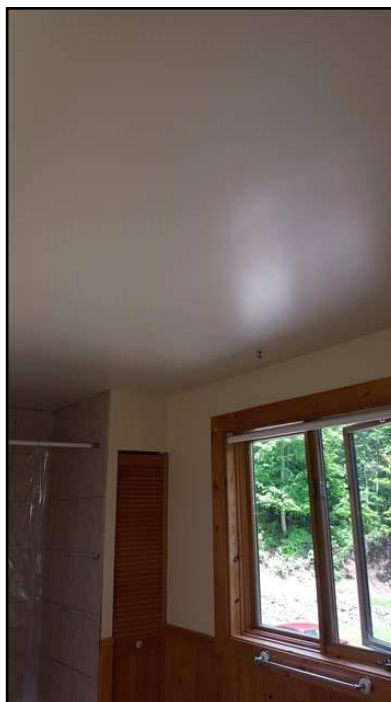
30. Condition: • [Missing](#)

Implication(s): Chance of condensation damage to finishes and/or structure

31. Missing

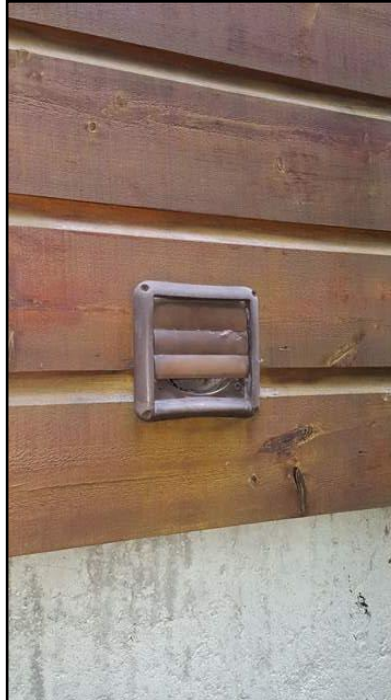
31. Condition: • [Damage](#)

Implication(s): Chance of condensation damage to finishes and/or structure

32. Damage

I recommend that all the exterior ventilation exhaust covers be repaired if they are broken and that they be cleaned so they shut when there is no air pushing through.
