INSPECTION REPORT

DE LA COLONIE

VAL-DES-MONTS, QC J8N 4A2

Inspection Date: Wednesday, December 20, 2017

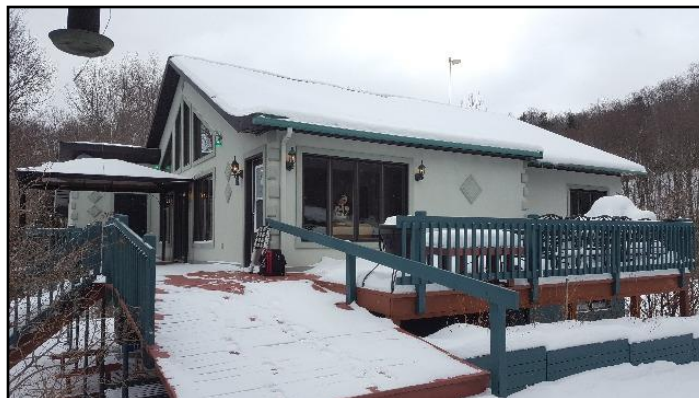
1. **Condition:** • I recommend that the client get the roof fully inspected once the snow has melted. In the springtime the client can give me a call and I will be happy to revisit the property to take a look at the roof.

1. Snow covered roof.

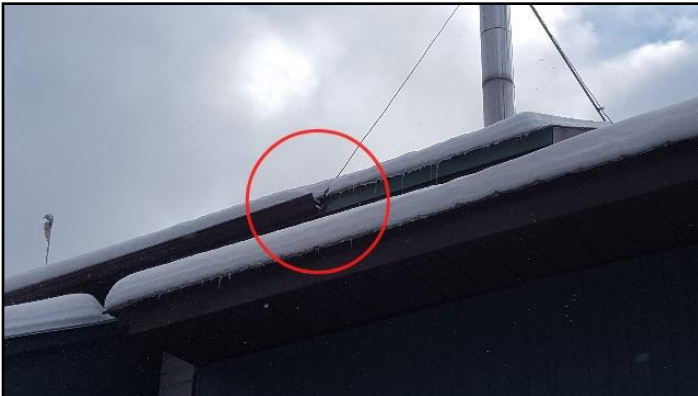
On the left side of the property there is a shed area. This area doesn't have a gutter system and the top roof is missing a end cap at the gutter. This needs to be replaced and improved

2. Missing end cap

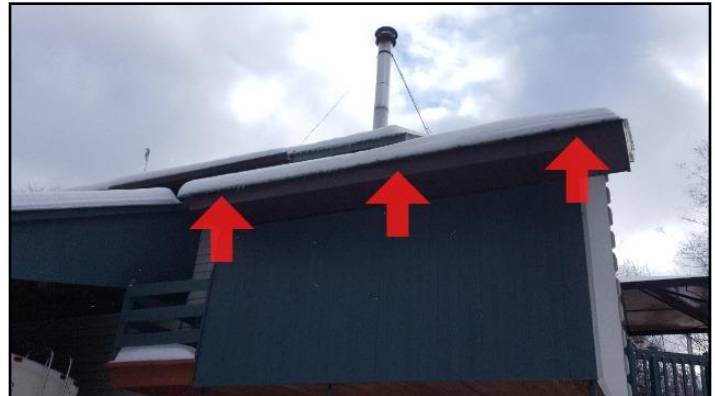
3. Missing

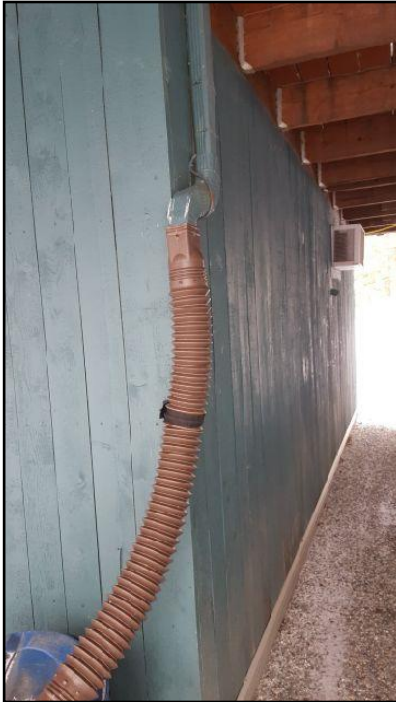
4. Should discharge 6 feet from building

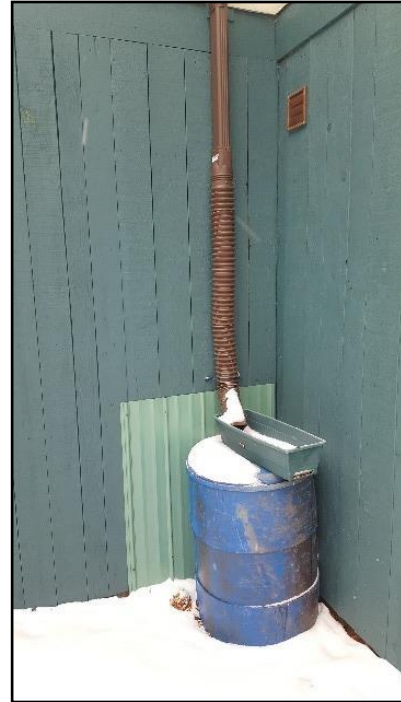
5. Should discharge 6 feet from building

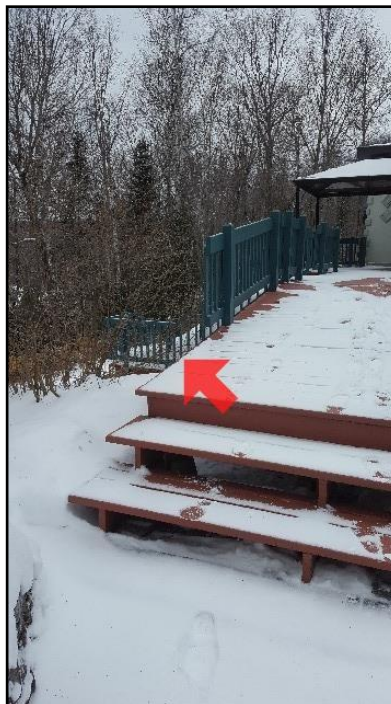
A guard rail is needed to prevent anybody from falling.

6. Missing

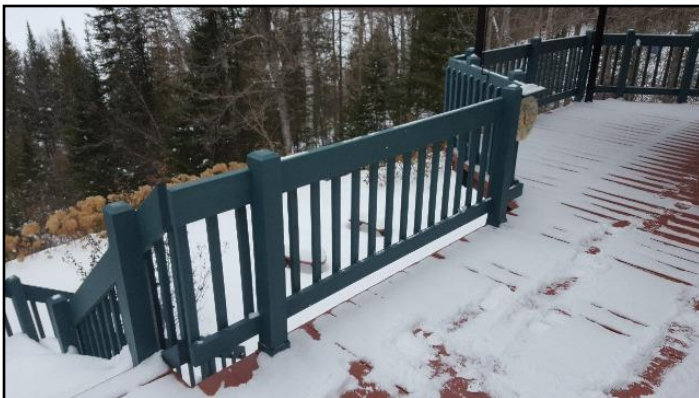
The deck at the top is more than six feet off the ground. The guard railings that are in place are too low, the right height for the guards should be 42". These areas needs to be corrected.

7. Too low

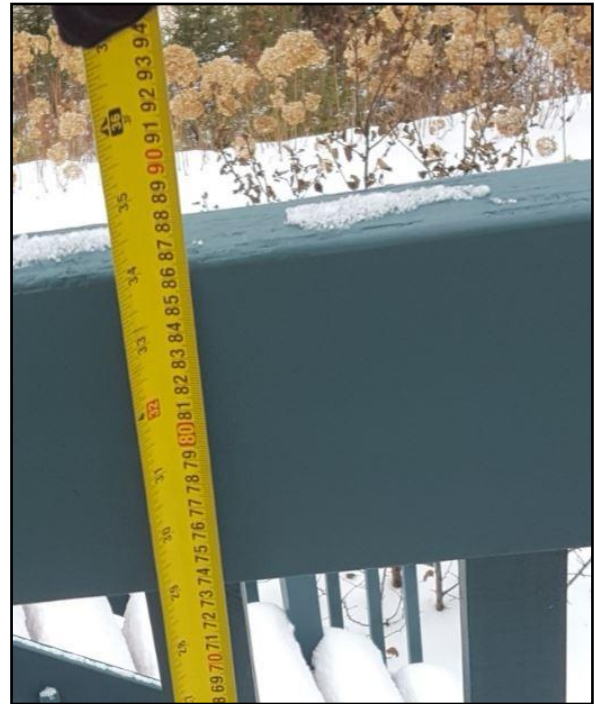
8. Too low

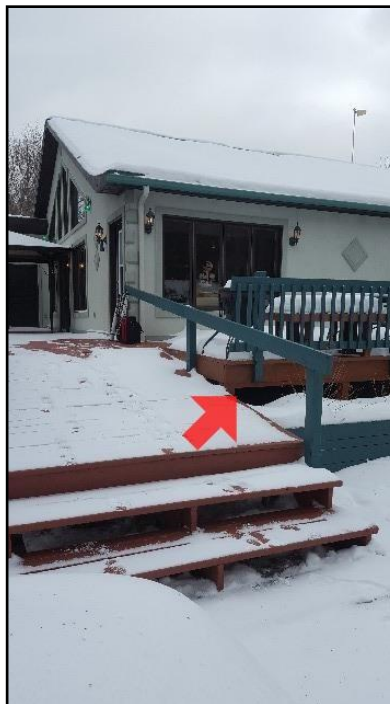
No spindles in this location please provide.

9. Missing

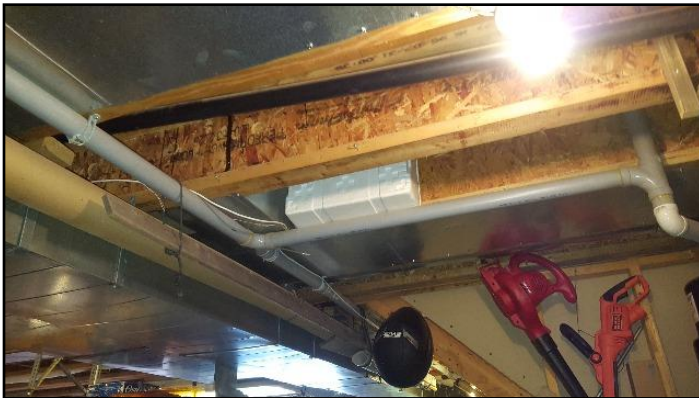
There were no gas seal from the garage to the living area. The walls and ceiling of the garage were open. These areas need to be closed off to prevent combustible gases entering the living area. The air ducts running through the garage needs to be sealed off as well. The supply and return ducts could circulate hazardous gases throughout the property.

10. Not gastight

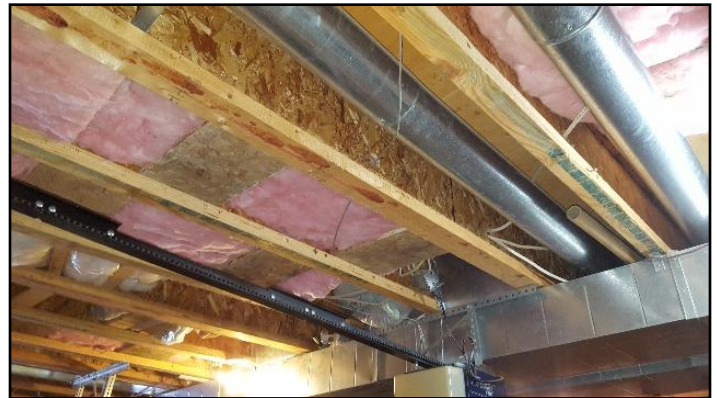
11. Not gastight

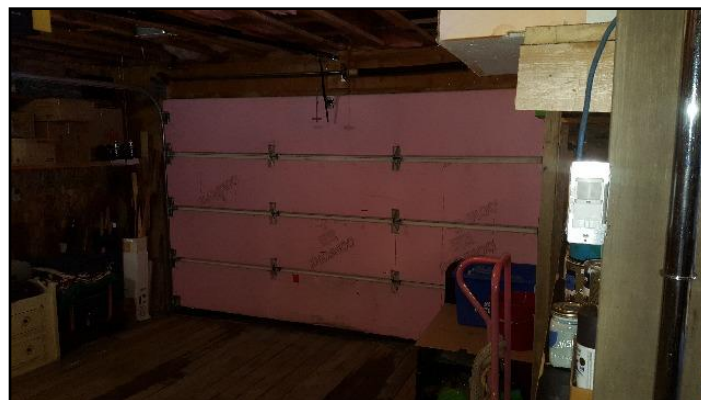
13. Combustible insulation

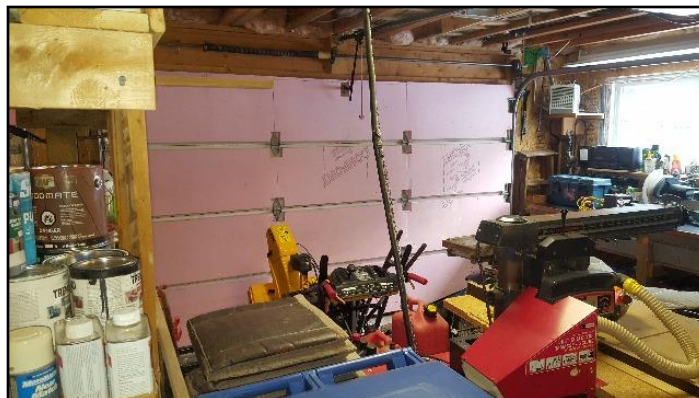
The right side garage door did not auto reverse when tested. This needs to be adjusted.

14. Fails to auto reverse

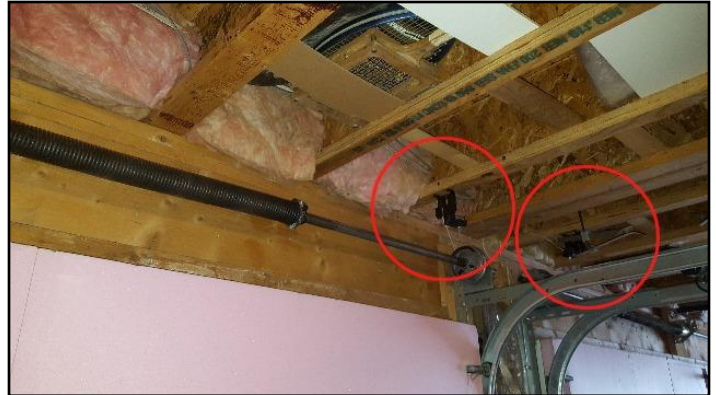
The sensor for the garage were located in the wrong location. It needs to be located closer to the floor about 12"-24" off the floor.

16. Sensors poorly located

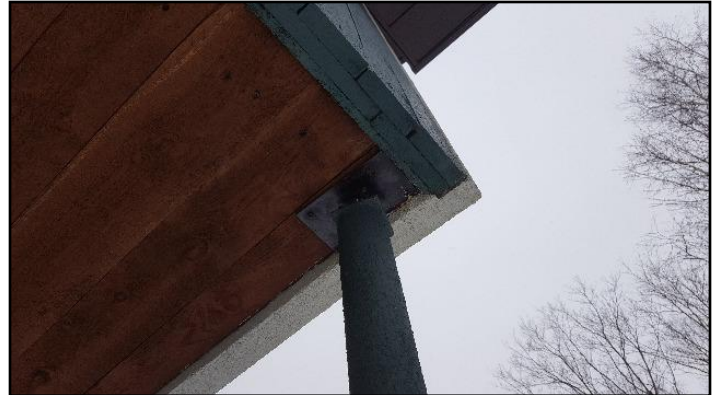
Some of the deck posts did not have all the screws set. There is quite a few open screw holes. I recommend screws be set in all the open hole locations.

18. Poorly secured at top

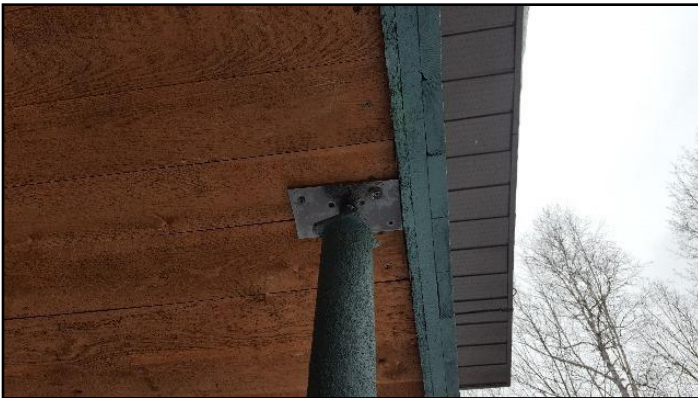
19. Poorly secured at top

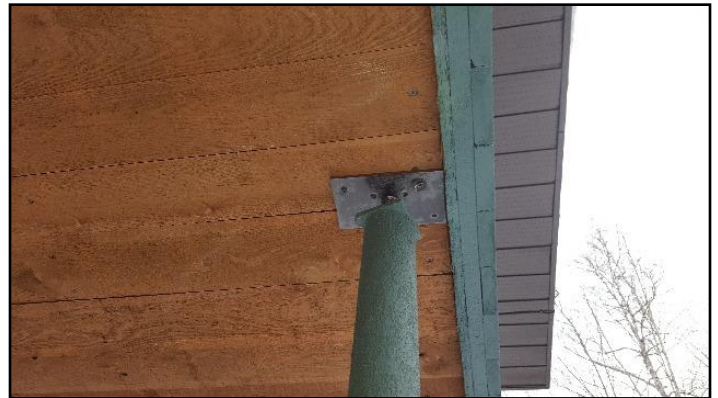
20. Poorly secured at top

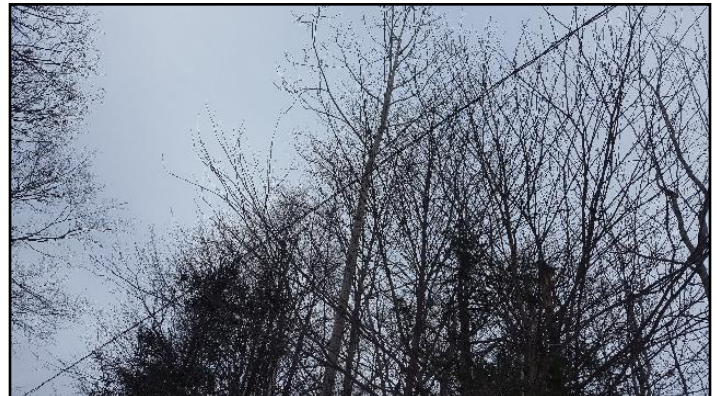
Tree branches needs to be cut back so it doesn't interfere with the service line. The client can contact the city and inquire about this.

22. Branches / vines interfering with wires

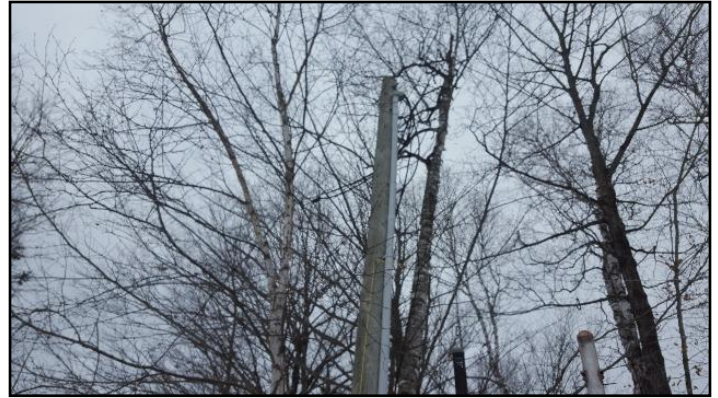
24. Branches / vines interfering with wires

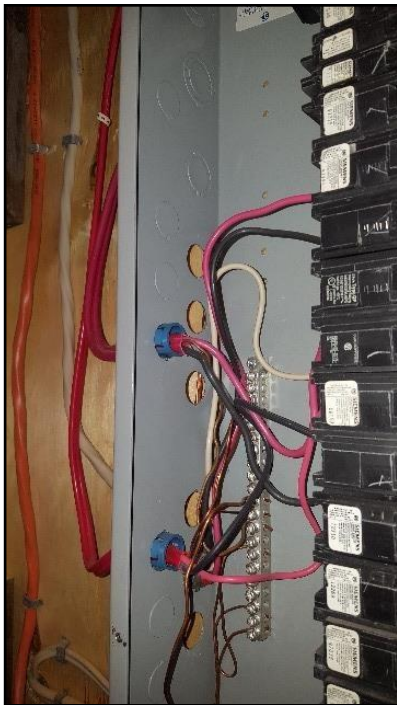
There were openings in the panels. This is a safety issue and needs to be corrected.

26. Openings in panel

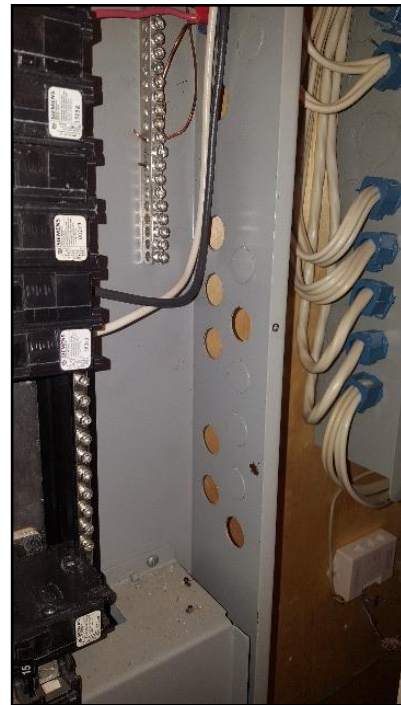
27. Openings in panel

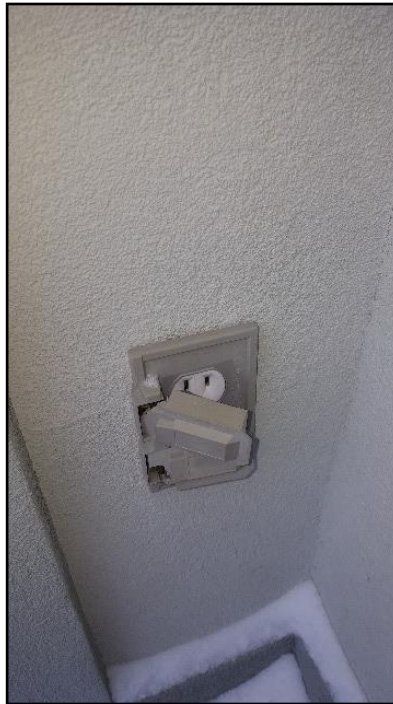
29. Damage

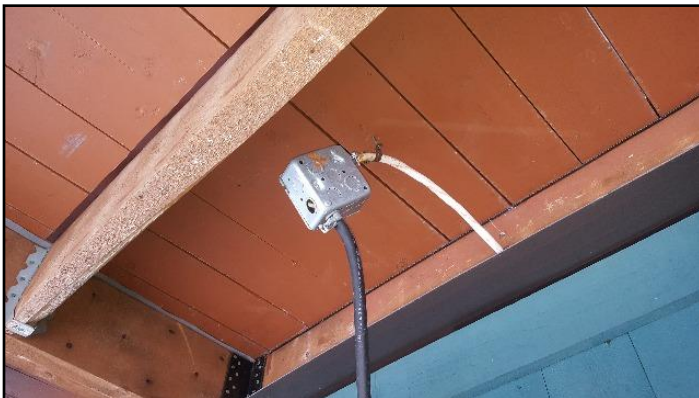
Receptacle boxes needs to be secured to prevent electric shock or fire. There were one electrical receptacle on the exterior that needs to be re-secured. In the garage there are two dedicated receptacles for the garage door opener. Both of these are loose and needs to be re-secured.

30. Loose outdoor

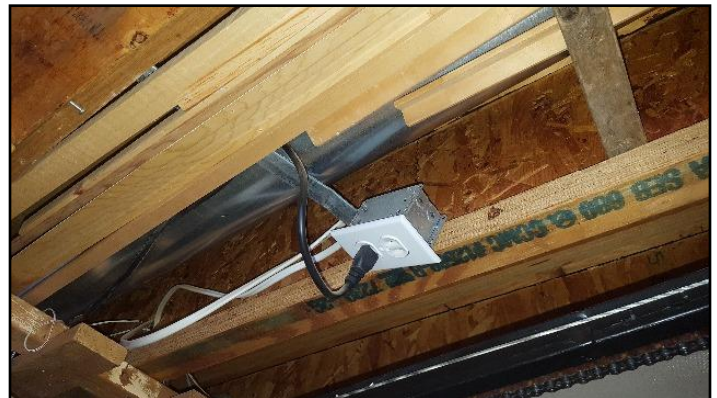
31. Loose garage

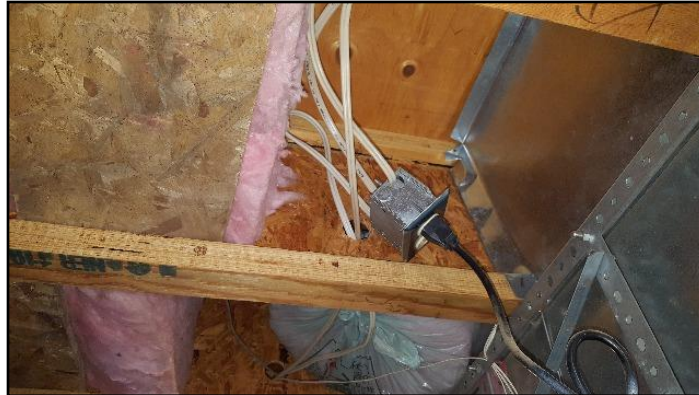
32. Loose garage

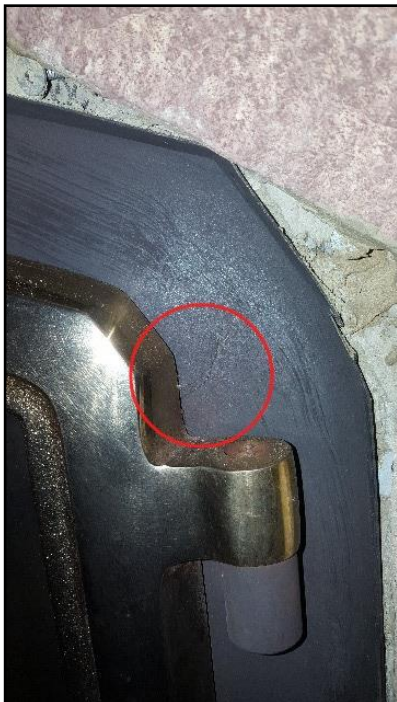
Two cracks were noted on the face of the fireplace. On the top left and right.

34. Cracked

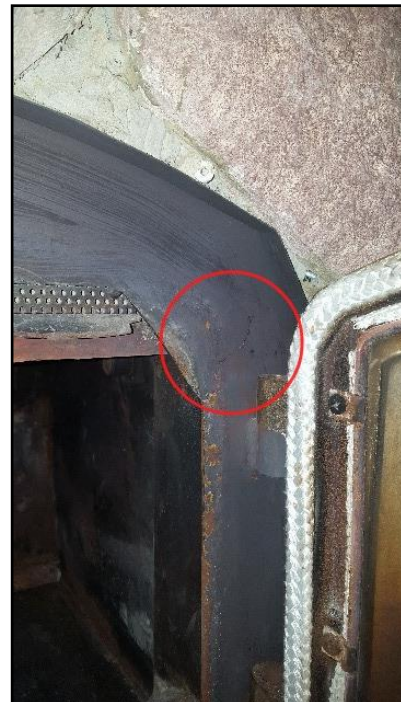
35. Cracked

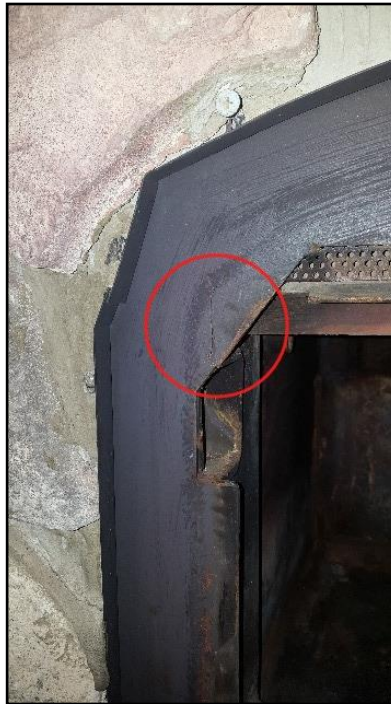
36. Cracked

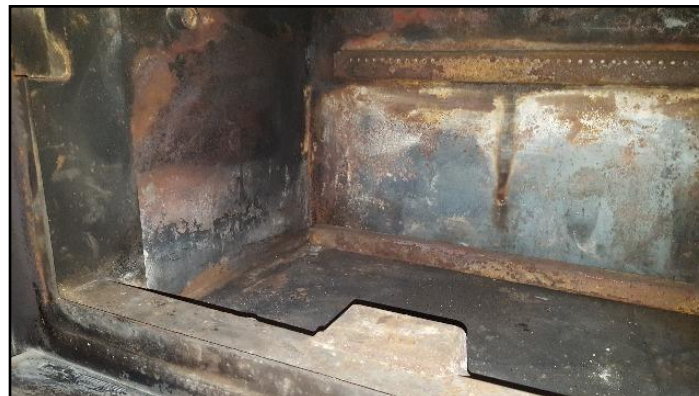
Missing firebrick.

37. Firebrick missing

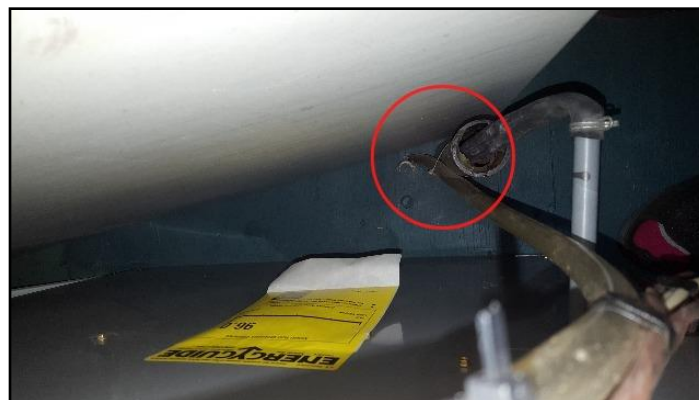
38. Improper discharge point

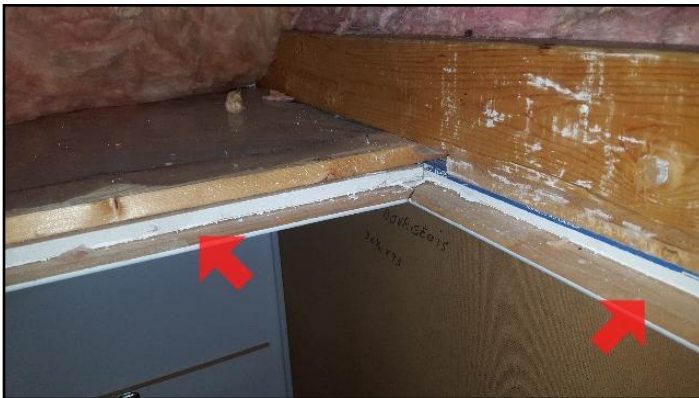
40. Not weatherstripped

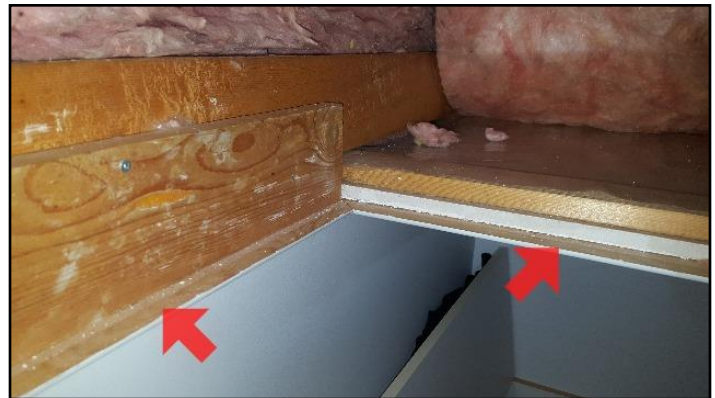
41. Not weatherstripped

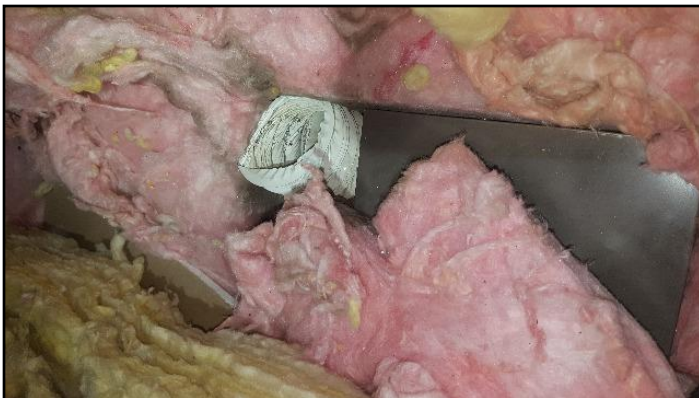
There were two bathroom exhaust vents that were discharging straight into the attic area. When inspecting the Attic there were signs of condensation on the metal substrate. This caused some wet spots in different locations on the insulation. These bathroom vents should be connected and directed so it can discharge the hot moist air to the exterior of the building.

42. Poor termination location

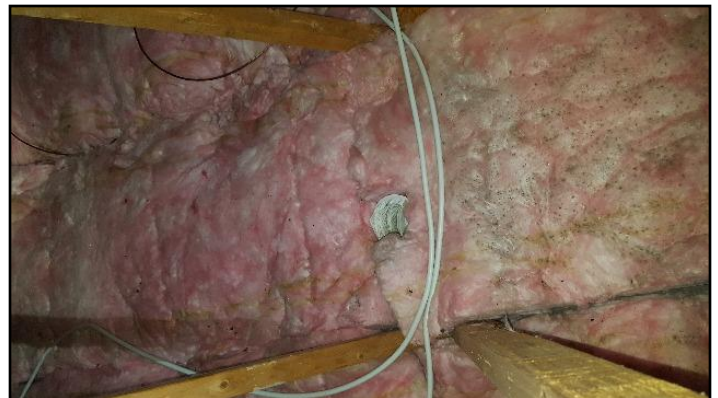
43. Poor termination location

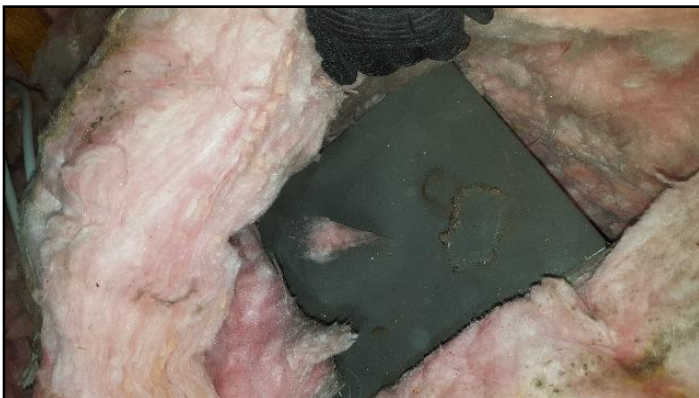
44. Poor termination location

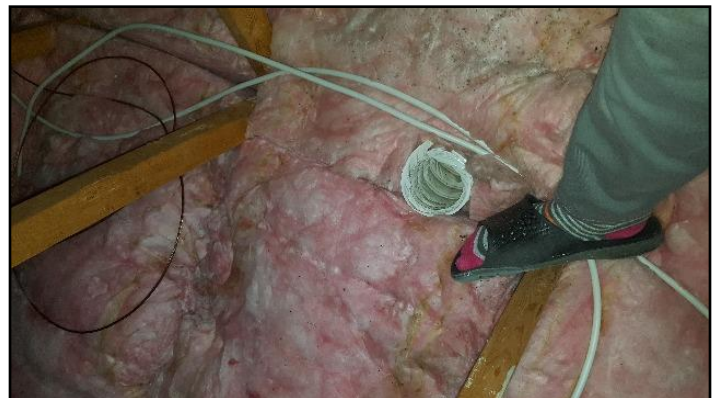
45. Poor termination location

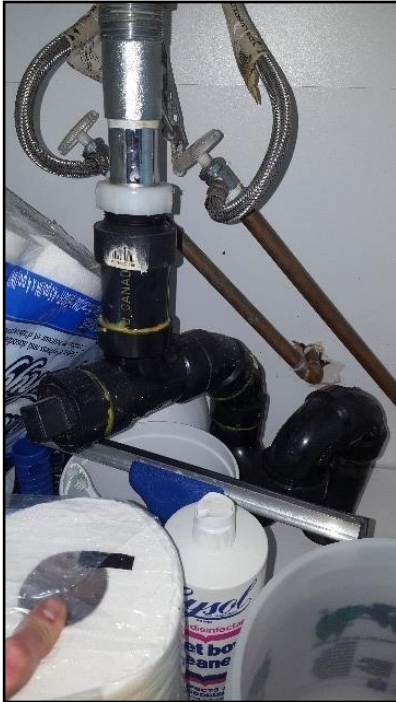
Improper drainage configuration were located in the two bathrooms upstairs.

47. Nonstandard shape or material

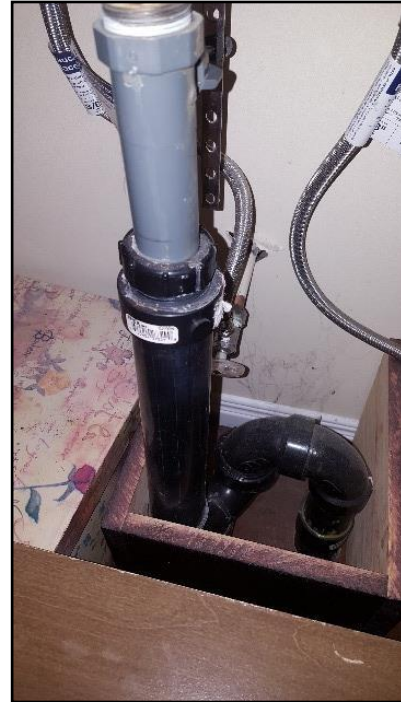
48. Nonstandard shape or material

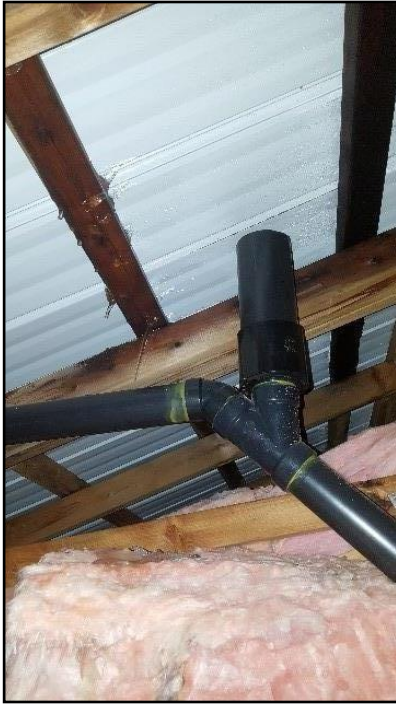
The main plumbing vent stack were terminated in the attic space. This is a wrong installation. The vent stack should go straight through the roof. Sewer gases can enter the property and this can also cause a lot of condensation damage. In this case there were condensation in the Attic on the metal roof.

49. Vent termination problems

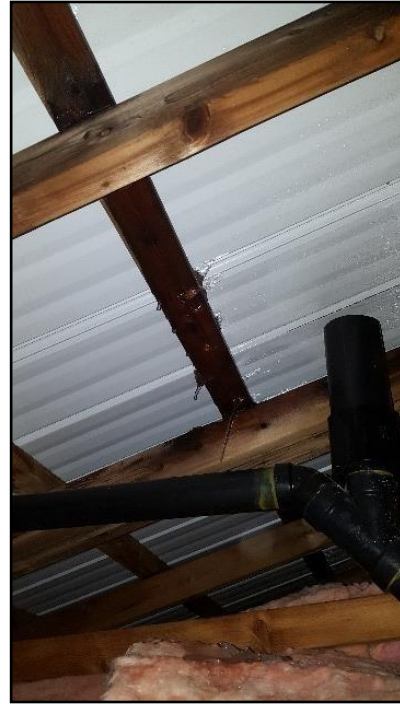
50. Vent termination problems

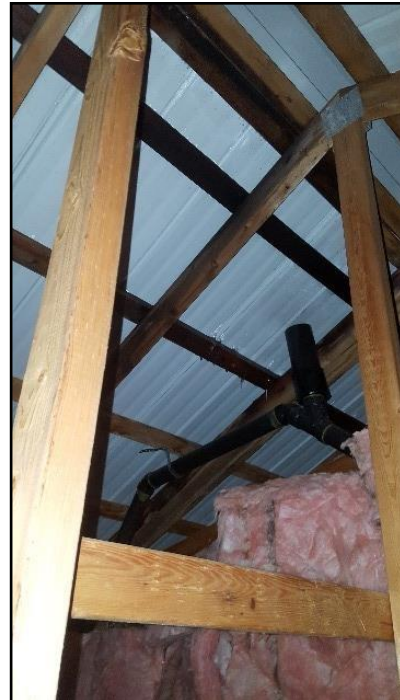
52. Vent termination problems

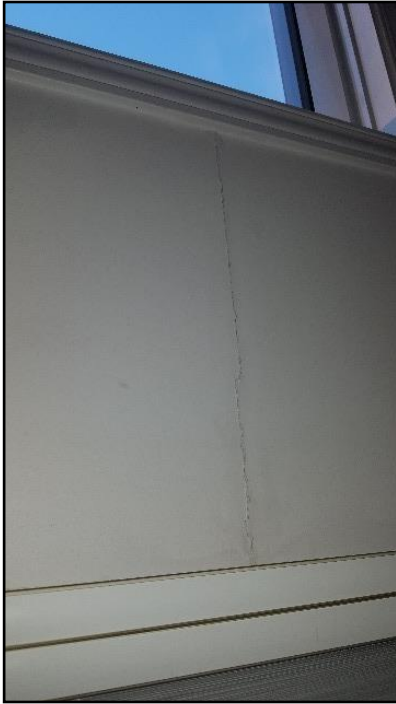
53. Cracked

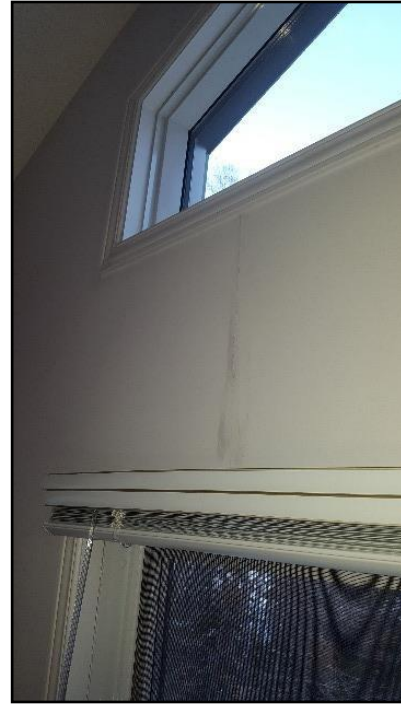
54. Cracked

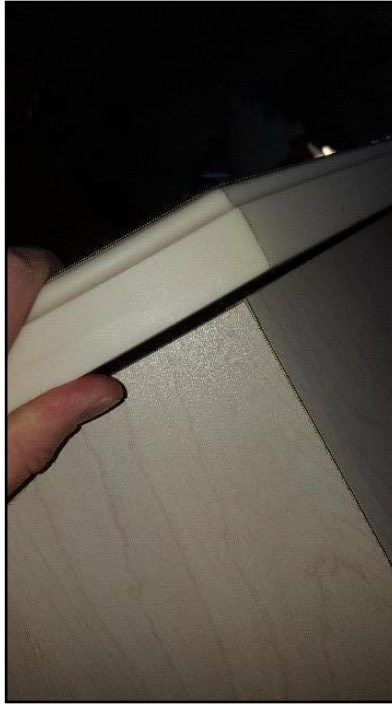
55. Entire top loose

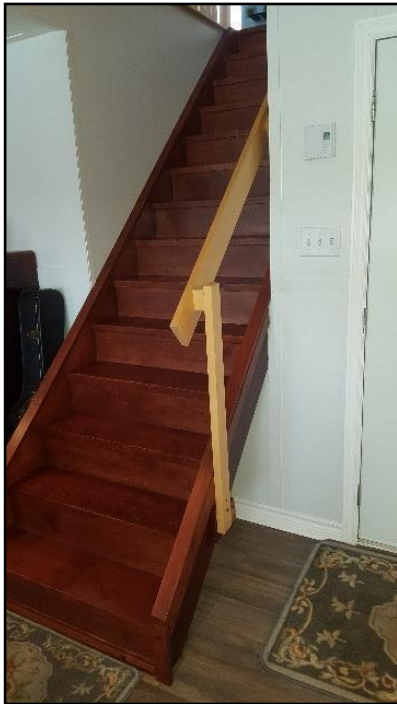
56. Missing

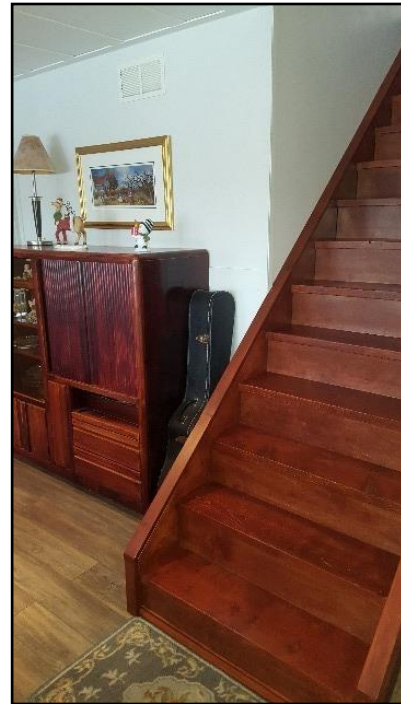
57. Missing
