INSPEC-PRO

PROFESSIONAL HOME INSPECTION.

RE: Report No. 1024
1583 Montée Paiment
Val des monts, QC
J8N 7P5

Report No. 1024
For inspection at:
1583 Montée Paiment
Val des monts, QC
J8N 7P5
on: Tuesday, June 27, 2017

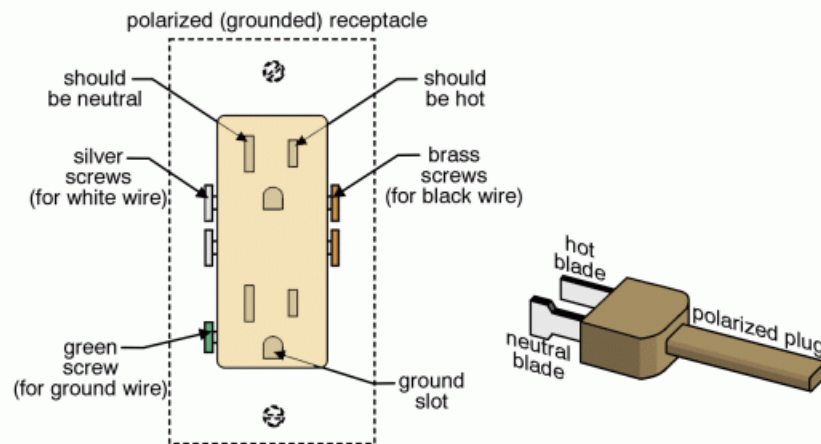
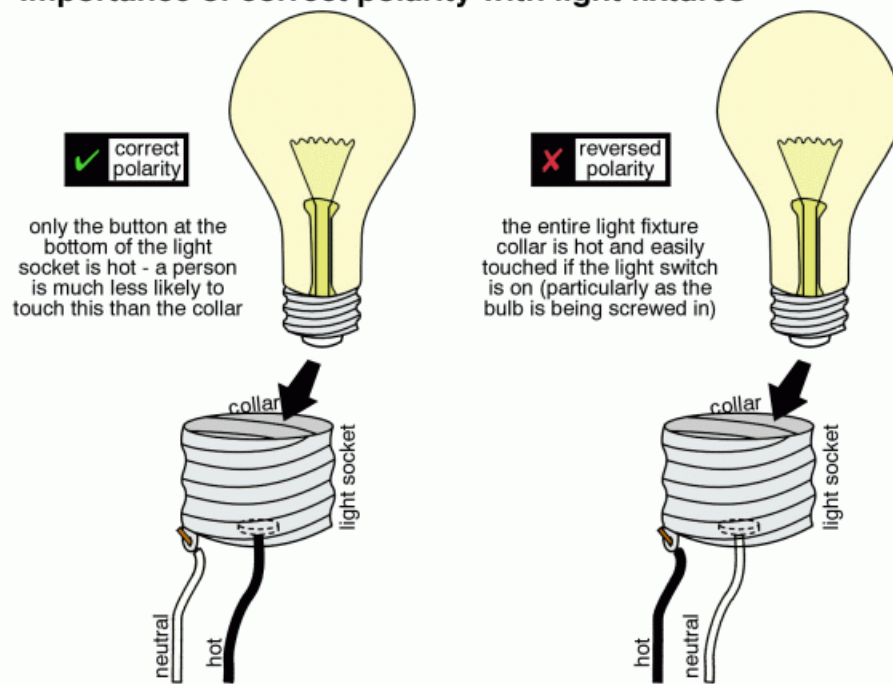
Reversed polarity

Condition: • [Reversed polarity](#)

Reverse polarity is when the hot and neutral connection at the receptacle are wired backwards. During the inspection I found a couple of outlets with reverse polarity I recommend that a qualified electrician come out and correct these problems and have a look at all the receptacles at the property to make sure that they are wired correctly.

Task: Repair

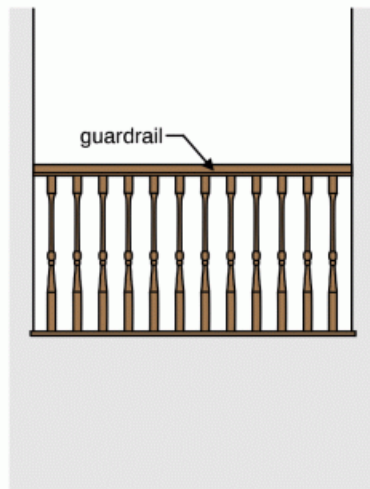
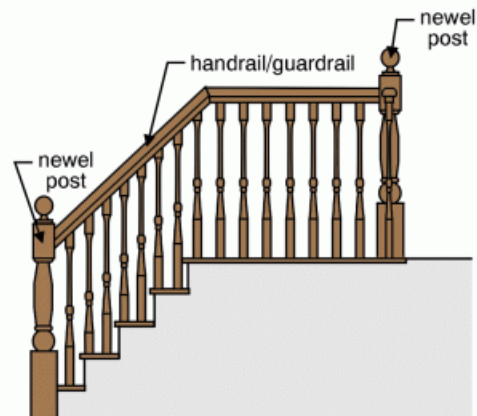
Handrail support

Condition: • [Loose](#)

The guardrail and handrail were loose and needs to be re-secured.

Implication(s): Fall hazard
