INSPECTION REPORT

DE LA COLONIE

VAL-DES-MONTS, QC J8N 4A2

Inspection Date: Wednesday, December 20, 2017

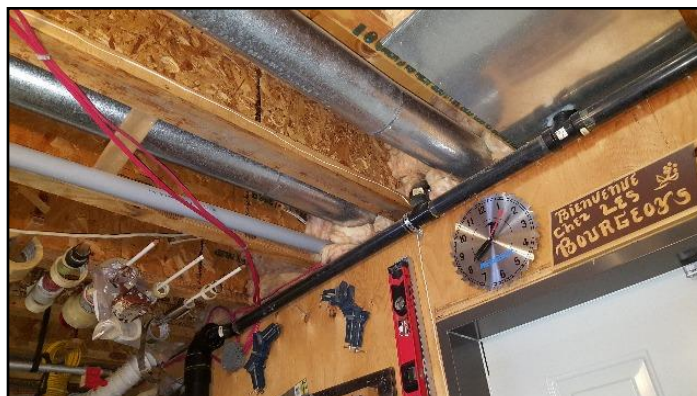
12. Not gastight

Condition: • Not gastight

There were no gas seal from the garage to the living area. The walls and ceiling of the garage were open. These areas need to be closed off to prevent combustible gases entering the living area. The air ducts running through the garage needs to be sealed off as well. The supply and return ducts could circulate hazardous gases throughout the property.

Implication(s): Hazardous combustion products entering home

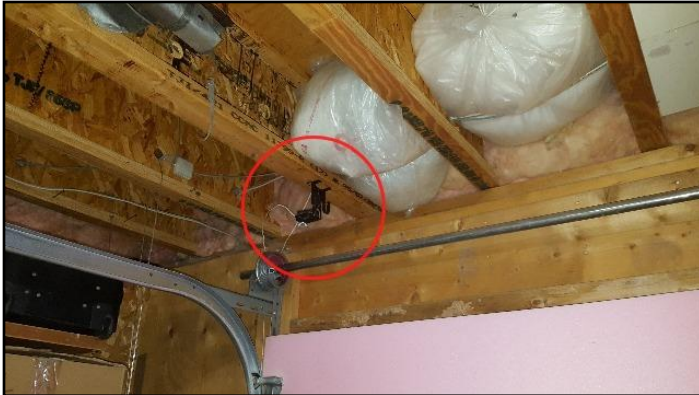
15. Sensors poorly located

Condition: • Sensors poorly located

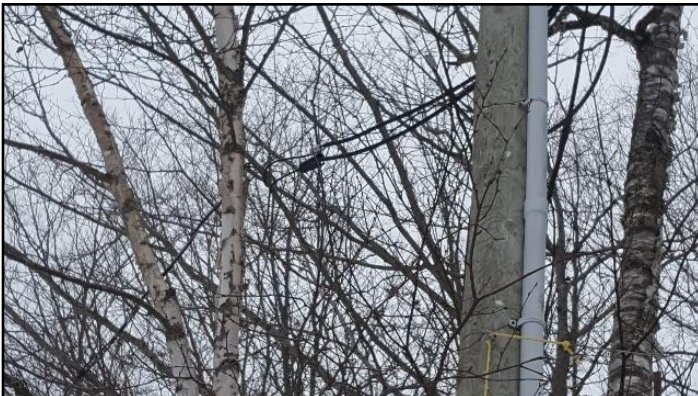
21. Branches / vines interfering with wires

Condition: • [Branches / vines interfering with wires](#)

Implication(s): Damage to wire | Electric shock | Interruption of electrical service

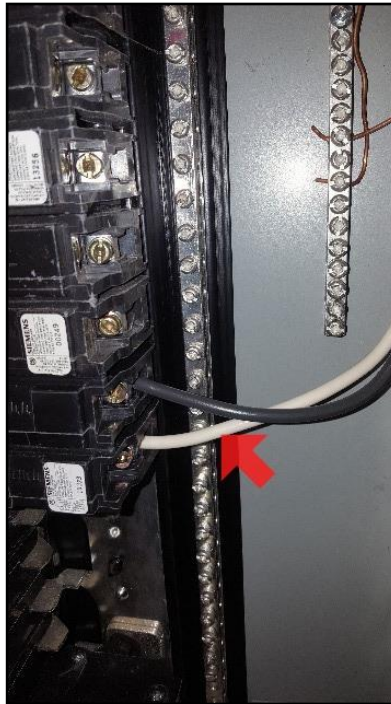
25. Fused neutral

Condition: • [Fused neutral](#)

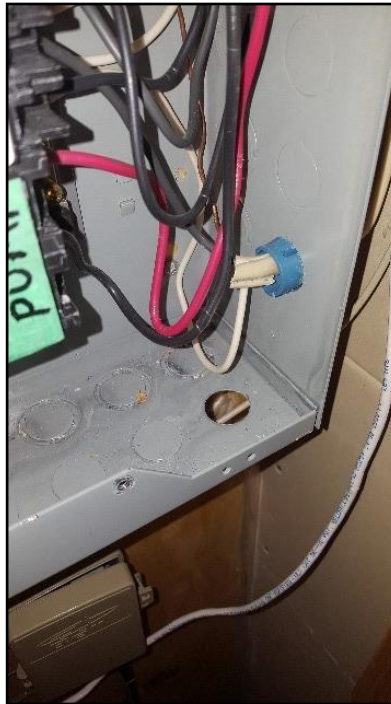
28. Openings in panel

Condition: • [Openings in panel](#)

Implication(s): Electric shock | Fire hazard

Task: Repair

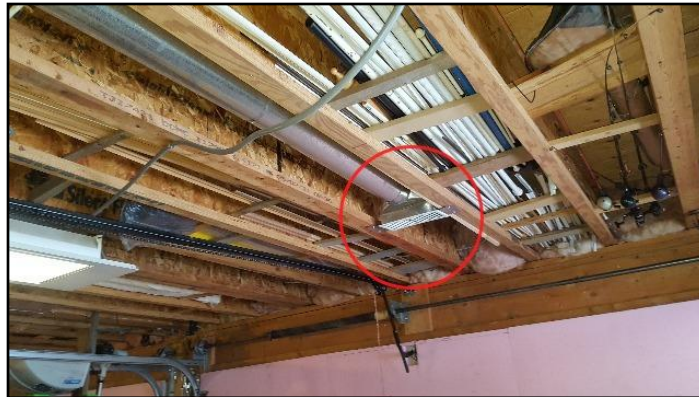
33. Registers or grilles in garage

Condition: • [Registers or grilles in garage](#)

Registers and grilles are not permitted in the garage. Combustible gases could find away into the property through these locations. This could be hazardous to your health.

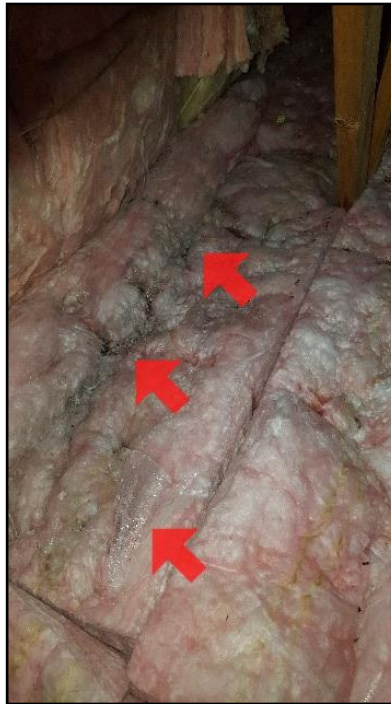
39. Wet

There were two bathroom exhaust vents that were discharging straight into the attic area. When inspecting the Attic there were signs of condensation on the metal substrate. This caused some wet spots in different locations on the insulation. These bathroom vents should be connected and directed so it can discharge the hot moist air to the exterior of the building.

Implication(s): Chance of condensation damage to finishes and/or structure

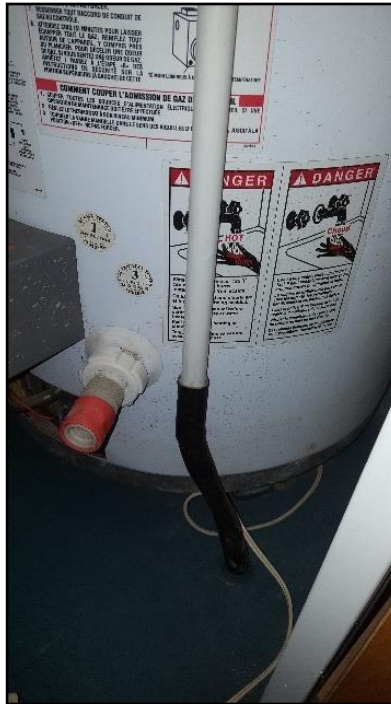
46. Discharge tube capped

Condition: • [Discharge tube capped](#)

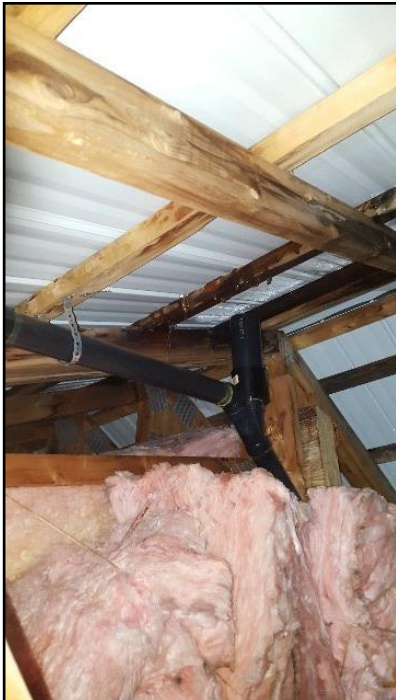
51. Vent termination problems

Condition: • [Vent termination problems](#)

straight through the roof. Sewer gases can enter the property and this can also cause a lot of condensation damage. In this case there were condensation in the Attic on the metal roof.
